File: 04-ALA-580 PM 5.0
04-1SS030
EFIS# 0400020869-0
North Flynn Road
Soldier Beam Wall with
Ground Tieback Anchors
Storm Damage

Subject: **REVISED FOUNDATION REPORT**

This Foundation Report (FR) supersedes our June 2, 2014 FR recommendations for the repair of the roadway distress and slope failure located on westbound of the State Route 580 PM 5, close to Livermore, Alameda County (see Figure 1).

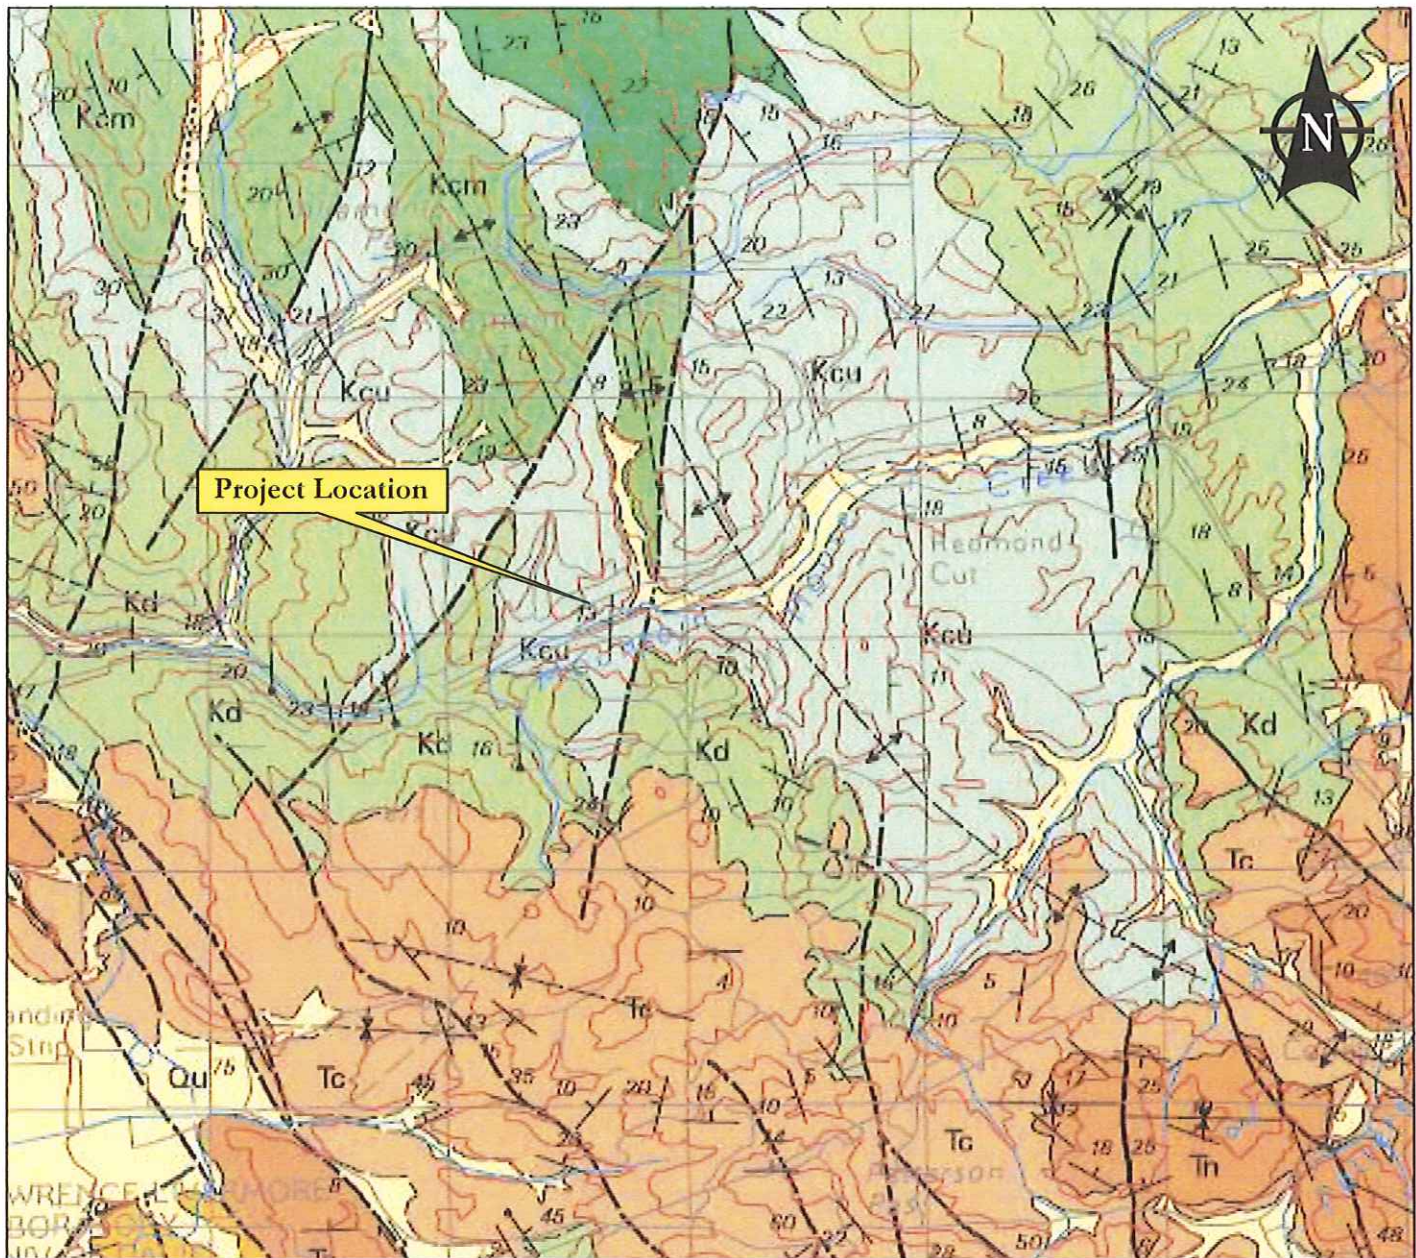
FIGURE 2

According to the Preliminary Geologic Map Emphasizing Bedrock Formations in Alameda County, California (Graymer and others, 1996), the site is underlain by unnamed shale, siltstone and sandstone (Kcu). This unit is Late Cretaceous in age and is described as medium to coarse grained, light gray, clean sandstone. Grains include quartz, feldspar, and biotite. Spherical weathering is common. In places the clean sandstone is interbedded with fine to medium grained, biotite and muscovite bearing wacke with mudstone rip-up clasts. Sandstone beds form packages up to 10 meters thick with 1 to 2 meters of interbedded siltstone and mudstone. The relevant portion of the map is included as Figure 2, Vicinity Geologic Map.

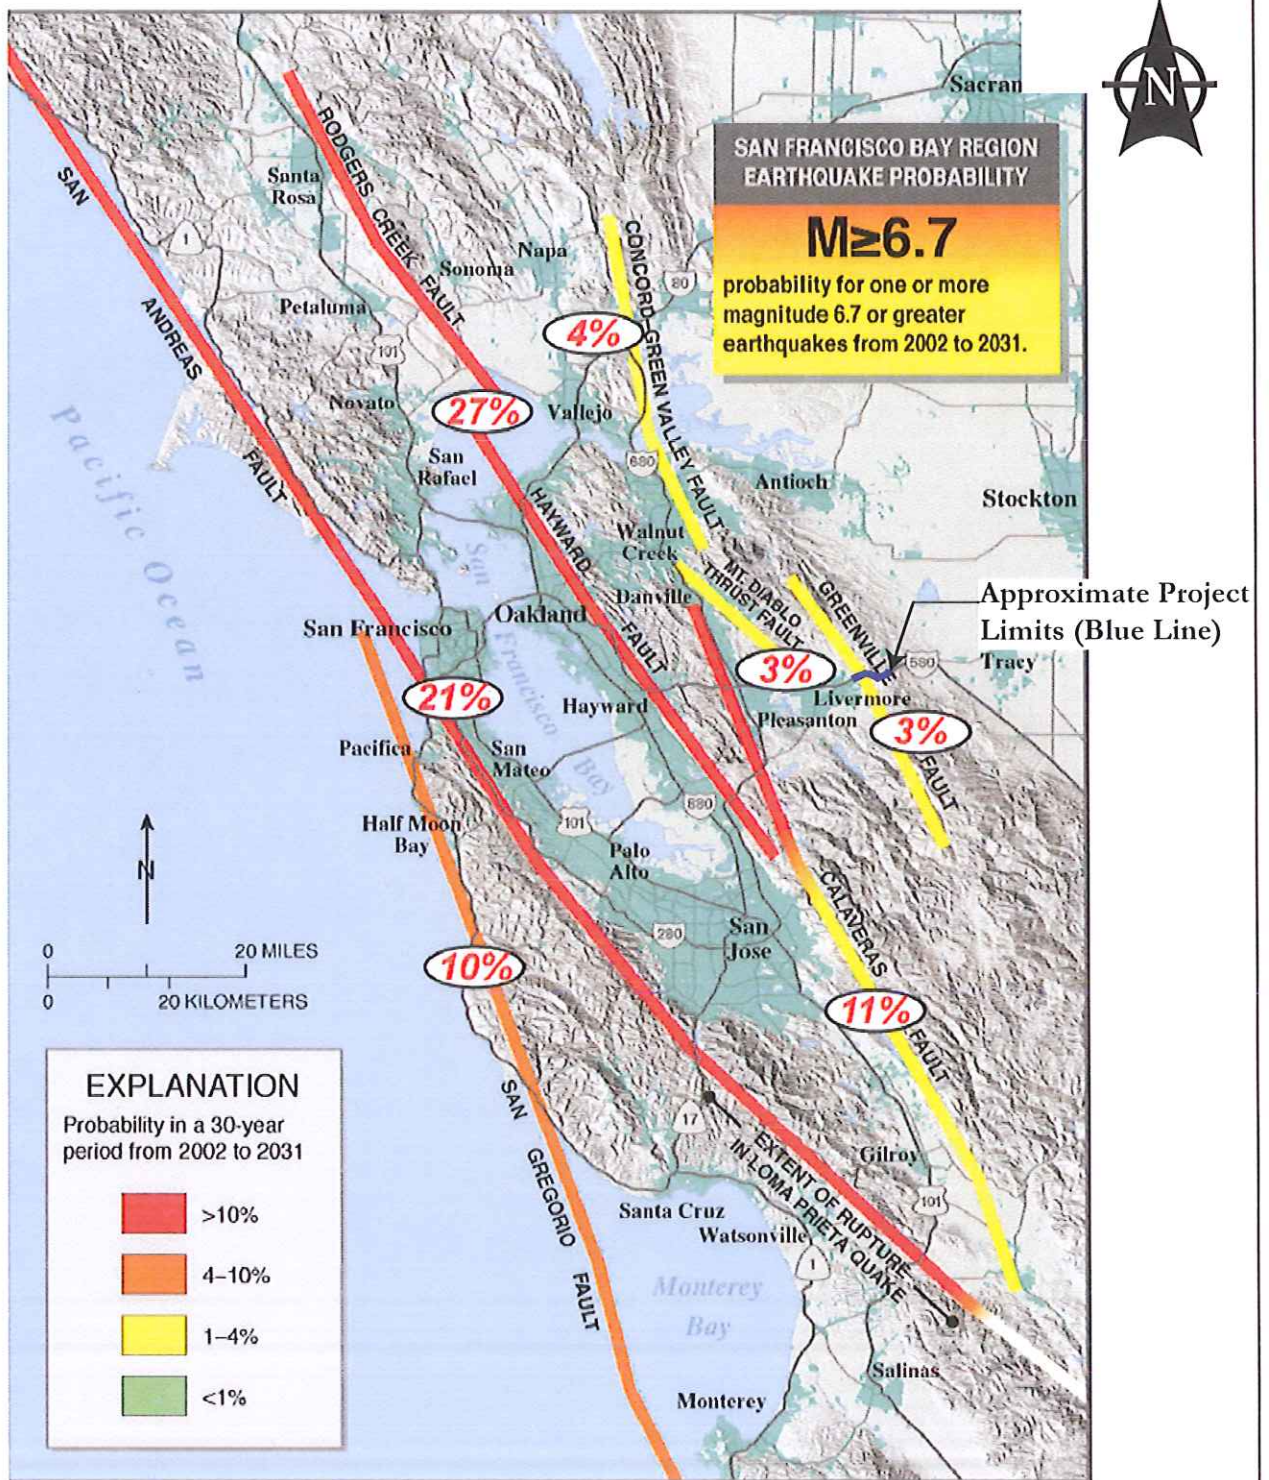
FIGURE 3

The U. S. Geological Survey concluded that there is a 62 percent probability for at least one "large" earthquake of magnitude 6.7 or greater in the Bay Area before 2032. There could also be more than one earthquake of this magnitude and that numerous "moderate" earthquakes of about magnitude 6 are probable before 2032. The San Andreas Fault is estimated to have a 21 percent probability of producing a magnitude 6.7 or larger earthquake by the Year 2032 (WGCEP, 2003). The probability of the Hayward, Calaveras, and Greenville Faults producing a similar size earthquake during the same time period is 27 percent, 11 percent and 3 percent, respectively (See Figure 3, San Francisco Bay Region Earthquake Probability Map).
